WHITE PAPER

The Many Passive Layer Causes of VSWR in Cellular

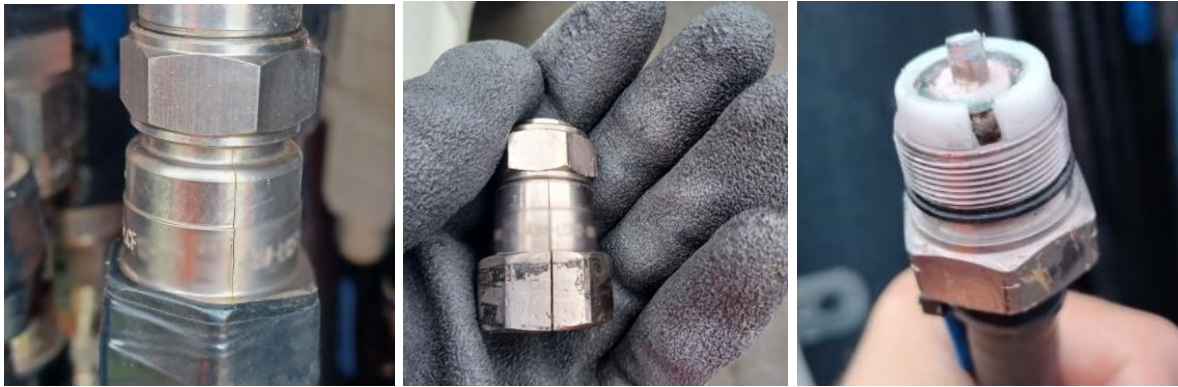
Recent example of (one of several) split connector bodies through installer over-torquing that led to water ingress and excessive VSWR approx 18 months after installation due to contact corrosion and dielectric breakdown even though this was located in a street cabinet

- Always use a calibrated torque wrench to manufacturer specifications.
- Always use the correct tools for the job

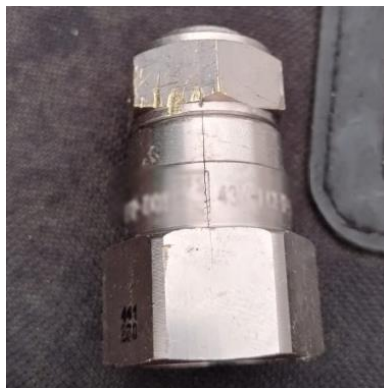
Severe hex nut marking and split body due to incorrect tool use and over torquing

- Always align mating faces concentrically
- Inspect connectors with a fiber-optic inspection scope or magnifier for contamination or wear.
- Avoid reusing connectors beyond manufacturer-stated cycle life.
- Use dielectric grease or sealing gel only when specified, as excess material may cause dielectric displacement or introduce mismatch.

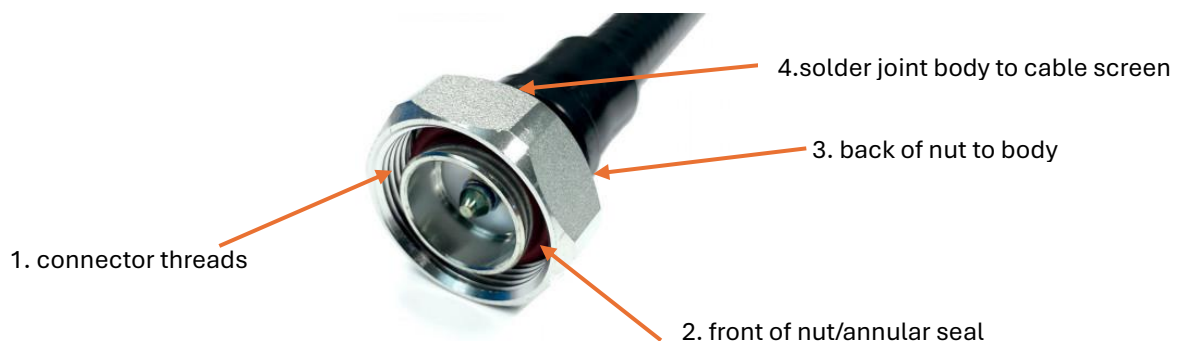
Potential Water Ingress Locations

1. Connector threads:

- Thread mismatch/lengths - mating part compatibility (not ALL manufacturer's parts mate well together)
- Incorrect torque
- Angular cable causing excess friction between mating halves when torquing
- Contaminants/grit in thread causing excess friction when torquing

2. Front of nut/annular seal

- Incorrect torque
- Angular cable causing excess friction or poor seating when torquing
- Damaged seal - reuse of seal, incorrect torque

3. Back of nut to body

- Angular cable causing excess friction or poor seating when torquing
- Contaminants/grit between nut and annular body feature

4. Solder joint - body to cable screen

Many cable manufacturers use manual soldering to effect the electrical joint between the cable screen and the connector body. This relies upon the operator to feed-in enough solder at the right temperature (applied by soldering iron) for the correct time to form a non-oxidised (low resistance & non-porous) connection. In this case an impervious cable boot MUST be applied to this location as it is impossible to fully visually inspect and validate the integrity of the joint for ingress protection.

- Use double-sealed or gel-filled weatherproof connectors.
- Ensure all connectors are induction soldered
- Apply weather shielding to all connection points**
- Install drip loops and ensure correct orientation of connectors (e.g., keep connectors upright to avoid pooling).
- Conduct proactive seasonal maintenance, especially after freeze-thaw cycles.

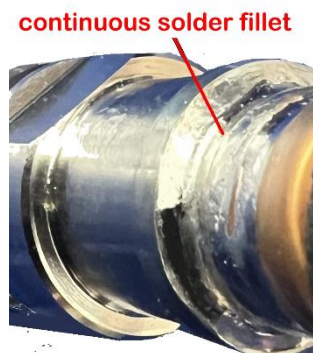
Typical Induction Soldered joint (Hughes production line 2025)

To provide a highly reliable 360° ingress seal AND controlled low resistance joint, for over a decade of cable manufacture Hughes have used high integrity induction soldering where a preset volume of high silver content solder is wrapped around the joint and high frequency induction consistently heats all of the metal parts to a known temperature that permits full solder flow for a preset time to prevent oxidation and to produce an impervious seal between the cable screen and the connector body. This process creates a highly reproducible low resistance joint. The cables are then cooled, visually inspected and VSWR tested. As this localised heating can mark the cable sheath, a purely cosmetic overmould is then applied that covers any bared copper and provides a location for branding. A second VSWR test is then applied to the finished cable before final visual inspection and QA release.

The use of induction soldering is the only accepted way of guaranteeing reproducible electrical and environmental sealing of this type of soldered cable connection.
